# Topographic Differencing for Determining Reservoir Sedimentation Using Archival Cartographic Materials and Modern Measurement Methods

**Abstract:** The aim of the study was to assess the sedimentation of the Klimkówka reservoir using topographic differencing (TD) analysis of digital elevation models (DEMs) created for two periods: before the reservoir was filled and after 30 years of operation. The archival model was developed from a scanned and calibrated analogue large-scale (1:5,000) topographic map with contour lines and elevation points. The current model was obtained by integrating unmanned aerial vehicle (UAV) photogrammetry and bathymetric measurements with a GNSS-positioned dual-frequency echo sounder. The accuracy of both models was analysed in detail, taking into account cartographic errors, map shrinkage, the scanning and calibration process, and the heterogeneous accuracy of the archival elevation data. Based on the DEM difference, the estimated sedimentation volume was considered unreliable. A detailed analysis of selected cross-sections revealed local accumulation processes in the backwater zone and slope erosion, but did not permit a reliable assessment of the si

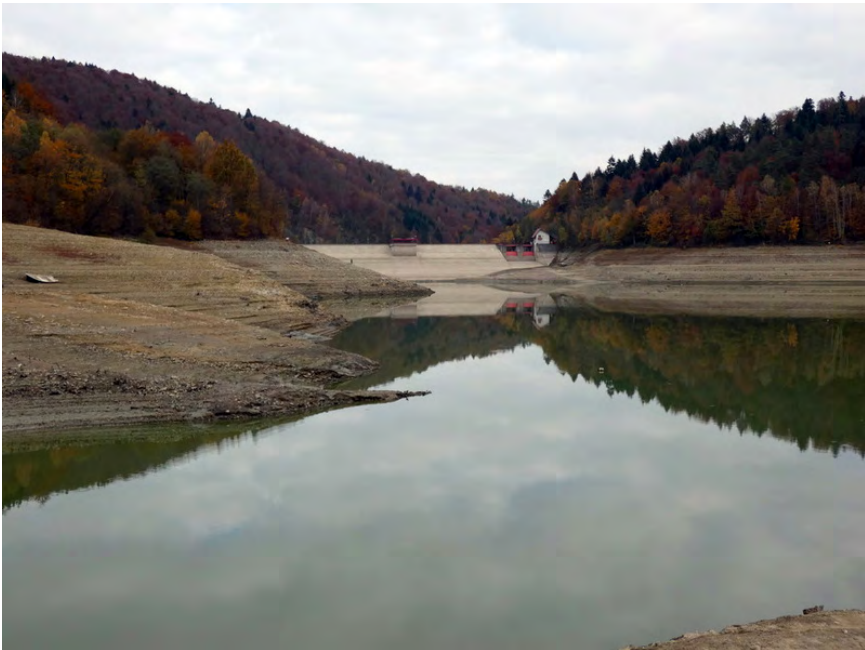
**Fig. 4.** Klimkówka reservoir in 2024 with a visible low water level  
(photo by M. Bodziony)

The low water level in the Klimkówka reservoir in 2024 (Fig. 4) resulted from a hydrological drought that created problems with maintaining the capacity of retention reservoirs [33]. This exposed some surface features: the foundations of former buildings and roads, located in the southeastern part of the reservoir (Fig. 5), which allowed these details to be measured with the Hi-Target H32 GNSS receiver and used as adjustment points. In the remaining parts of the area currently underwater, the land boundaries visible on the archived map were used. It was assumed that these boundaries are identical to the plot boundaries, whose course has not changed significantly since the 1970s. After the land was expropriated for the reservoir basin, no land consolidation was carried out.

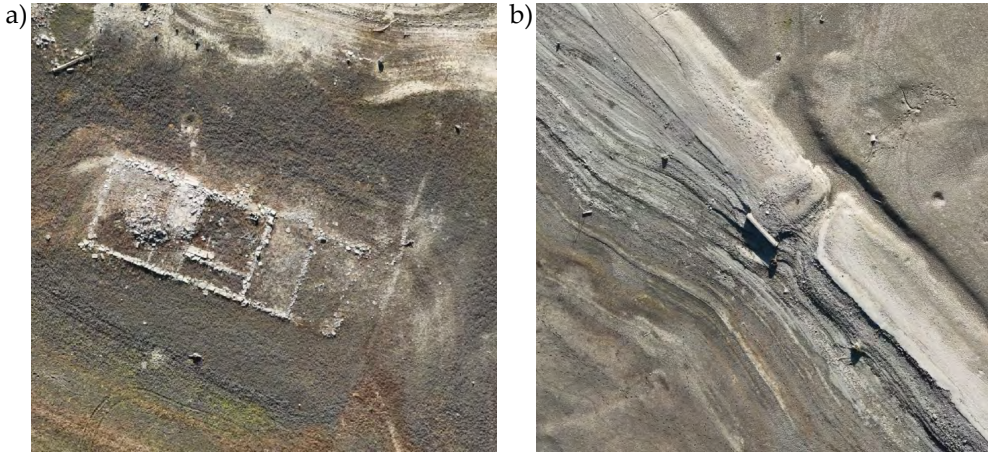
**Fig. 5.** Fragment of the orthophotomap with terrain details constituting adjustment points for the calibration of the archival analogue map: a) remains of old buildings; b) remains of a road with a culvert on the exposed part of the reservoir bottom

Twelve points were identified in the field, based on which the archival 1:5,000 scale topographic map was calibrated using a second-degree polynomial. The resulting Root Mean Square Error (RMSE) was 5.25 m. The prepared base map was vectorised in AutoCAD. The vectorisation included all contour lines and characteristic elevation points readable on the calibrated map. Based on the vectorised data, a DEM was generated for the first period (before the reservoir flooding).

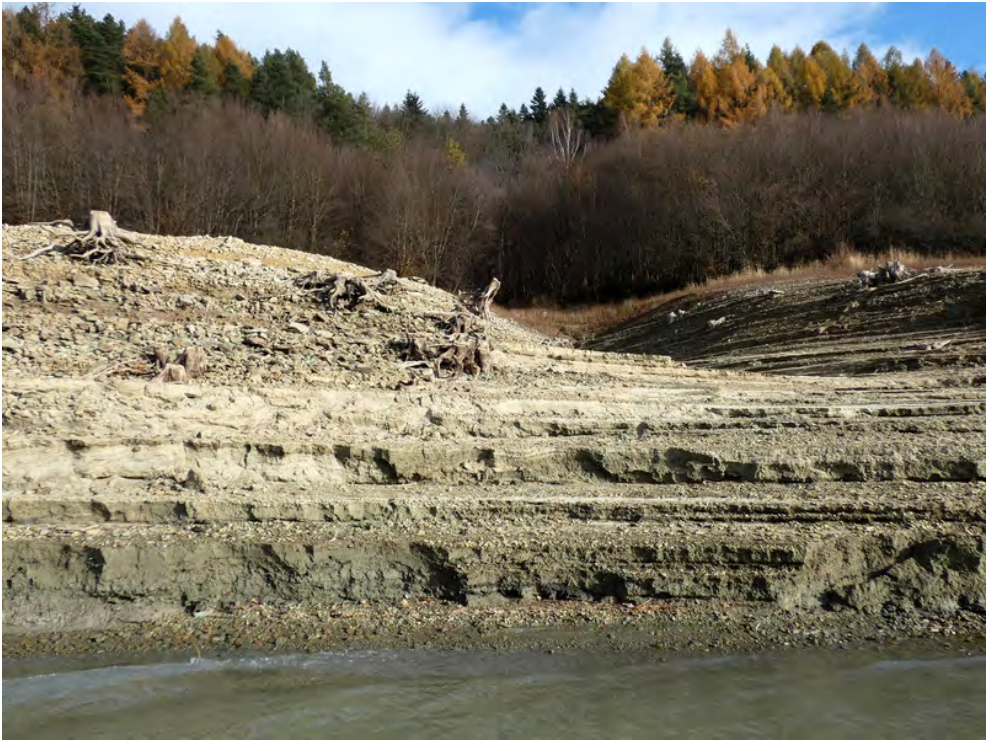
**Fig. 10.** Erosion terraces on the right bank of the Klimkówka reservoir  
(photo by M. Bodziony, 2024)

As shown by the calculations in Figure 9, in the northern part of the reservoir, the reservoir's banks exhibit very high variability in ground elevation, reaching up to 10 m. The terrain slopes there reach 100%. On the western bank of the reservoir, significant changes indicating a lowering of the terrain surface elevation may result from a 50-year period of abrasion or earthworks related to the construction of the dam. On the eastern bank, the accumulation of alluvial deposits, causing elevation changes of 5 to 10 m, cannot be regarded as reliable. Based on an on-site inspection, erosion in the form of terraces is visible on this very steep bank (Fig. 10).

assessment of statistically significant erosion values. However, direct field observations indicate that this process is occurring (Fig. 10).

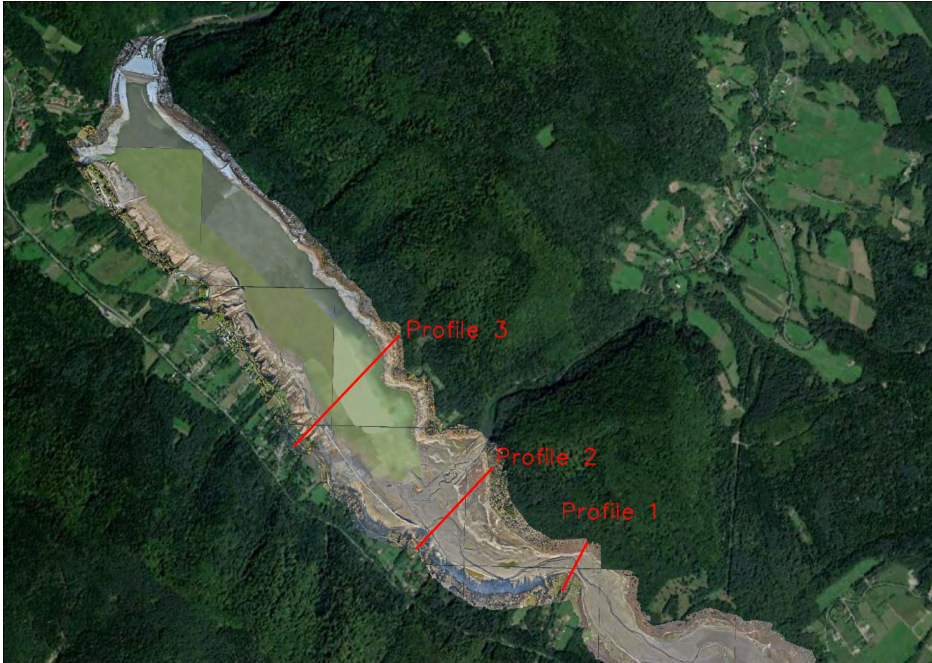
**Fig. 12.** Location of cross-sections within the reservoir area, comparing archival and current elevation data

Three cross-section locations, marked as 1, 2, and 3 in Figure 12, were selected for further analysis of the accuracy of the available data to assess the feasibility of determining siltation in the Klimkówka reservoir.
