Haruhiro Shiraishi¹, Yuichiro Usuda²

Real-Time Building-Damage-Extraction Technology from Ground-Based Video Footage Using Normalized Difference Red/Green Redness Index

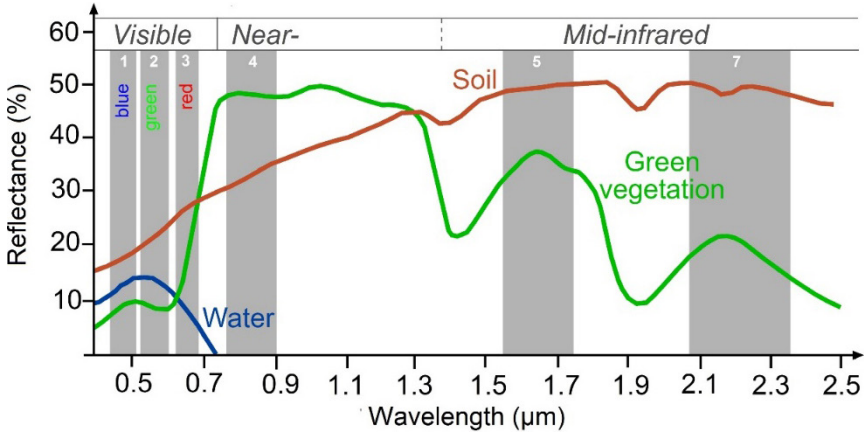
Fig. 1. Wavelength rates by physical properties (water, vegetation, soil)

Details regarding the characteristics of spectral reflectance are shown in Figure 1.

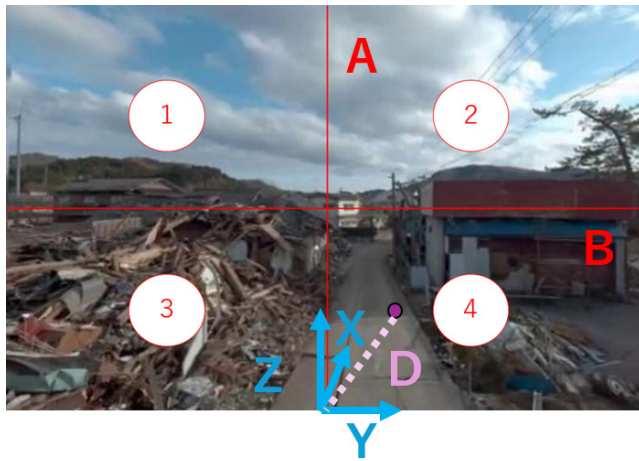
Fig. 4. Image of affected area divided into top, bottom, left, and right portions

As shown in Figure 4 (in images that were captured from a road), it is intuitively understood that the upper half of the image (namely, Regions [1] and [2]) depicts distant areas or the sky; therefore, it is reasonable to exclude the upper half of an image when analyzing nearby surroundings. The image is then divided into the lower-left and lower-right halves (referred to as Regions [3] and [4]). If RI effect is significant on either side, the image is classified as a “damaged image.” This approach ensures accurate classifications – even in those cases where only one side of a road shows collapsed buildings. This segmentation method was applied to both the mean-based calculation method and the area-based method.

The theoretical background for dividing the image into upper and lower as well as left and right is based on the formula for straight-line distance in three-dimensional space ($D = \sqrt{x^2 + y^2 + z^2}$). As is shown in Figure 4, Dividing Line A for the upper and lower regions corresponds approximately to the horizon. It can be visually understood that the closer an area is to the intersection of Centerline A (horizontal) and Centerline B (vertical), the further away the scene that is depicted in the image.

If the shooting position is considered to be the origin, the straight-line distance in the image can be calculated. The depth dimension of the image is evenly divided by the actual length in the depth direction (x). It becomes apparent that the length in the depth direction decreases as it approaches the intersection of A and B (which represents distant scenes). Similarly, the lengths in the horizontal (y) and vertical (z) directions also decrease as they approach the intersection of Centerlines A and B.

Using these image characteristics, it is evident that the further away an area is from the intersection of Centerlines A and B, the smaller the straight-line distance values become; this indicates the proximity to the shooting location.

The purpose of using RI is to detect and map collapsed buildings; therefore, any collapsed buildings near a shooting location would have smaller values in the vertical direction (z) as well as smaller values in the depth (x) and horizontal (y) directions. This minimizes any errors in the latitude and longitude calculations.

For images that have been captured by a dashcam, the road typically corresponds to the area near the intersection of Centerlines A and B (distant regions); these are excluded from the analysis. Hence, dividing the lower half of the image into left and right sides and evaluating each side of the road without complex calculations is deemed to be a more efficient method for obtaining results while minimizing computational load.

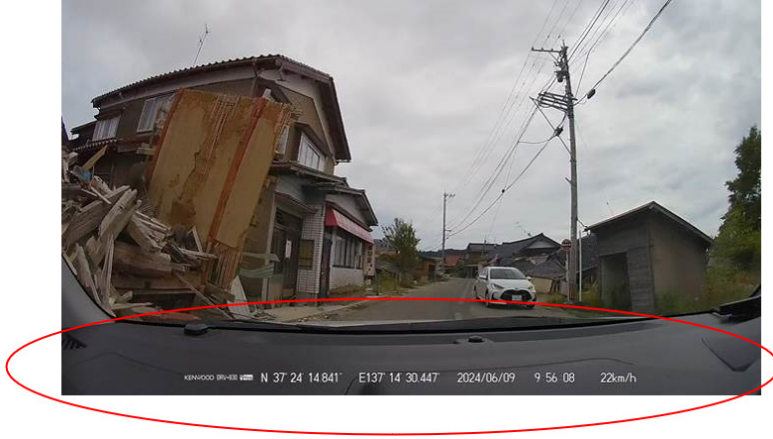
Fig. 8. Image with lower area obscured by front end of vehicle

Furthermore, the lower half of the image was obscured by the vehicle’s front end, and a correction factor of 2.0 was applied to calculate the proportion of “damaged pixels” that were used in the results (as illustrated in Figure 8).

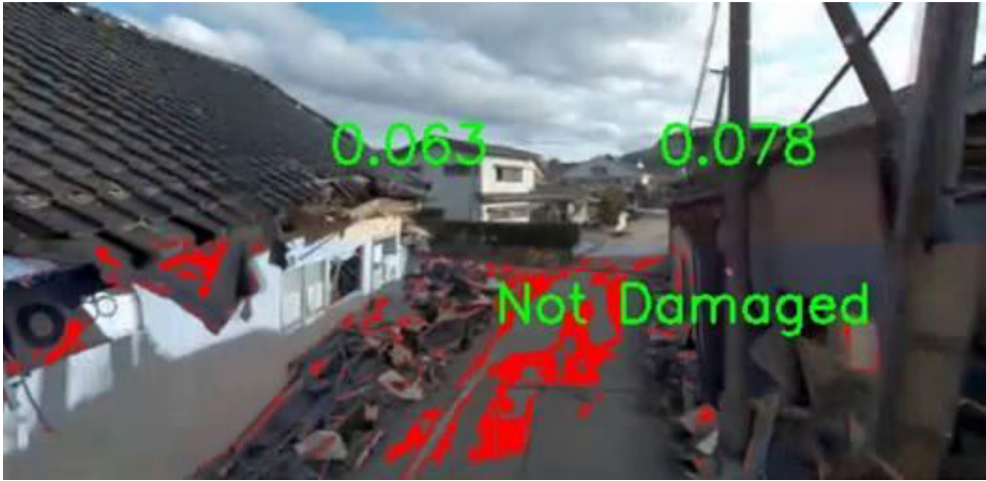
Fig. 9. Example of accuracy degradation when using unrelated images for calibration

When images that were unrelated to the affected areas were used for calibration, a significant drop in the accuracy could be observed (as shown in Figure 9). This highlighted the importance of conducting one’s calibrations based on regional standards.
